Water Quality in Maungani, South Africa

GROUP C

Sanitary Inspection Results:

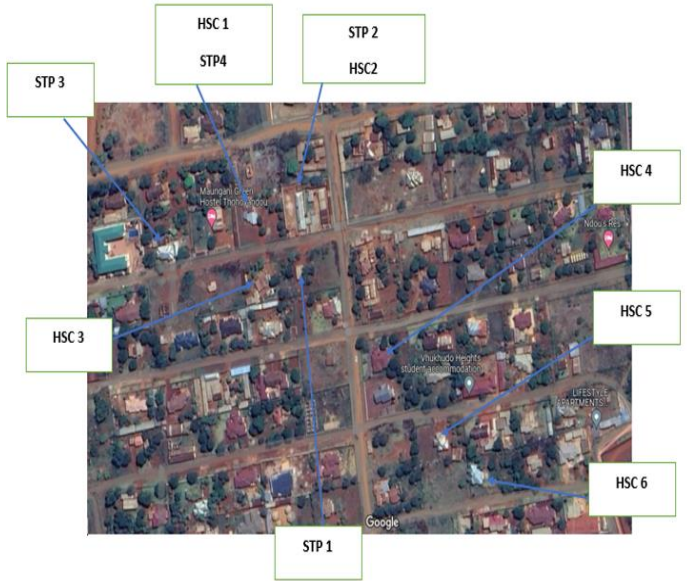
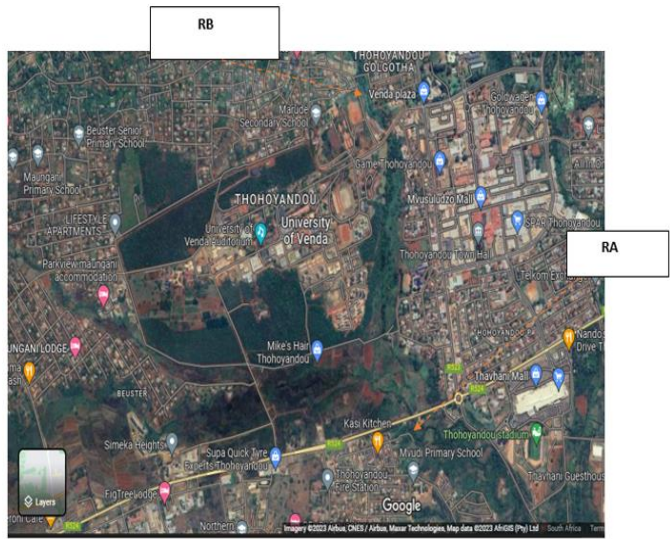
Figure 2: Sampling locations in Maungani village

Water samples were collected from 6 households and from the nearby river. The water was observed to be clear and free from any visible contaminants. But the results revealed that there are some traces of e coli and total coliforms.

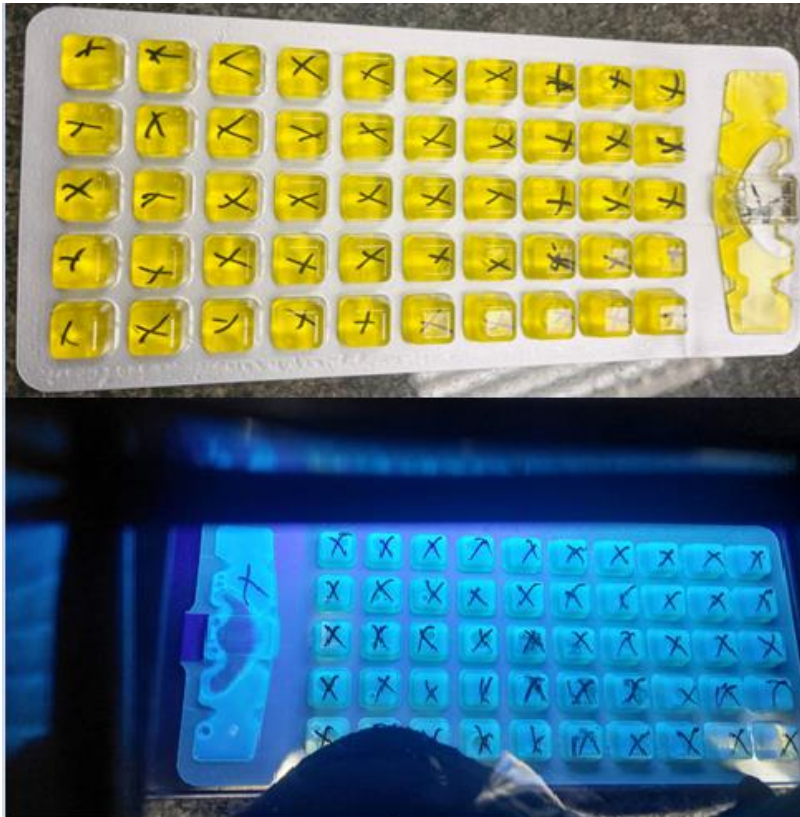
5.2 Testing presence of microorganism

The development of yellow color represents Coliforms and potential presence of disease-causing microorganisms (e.g., The fluorescence of wells shows the presence of *E. coli*).
